CASE: Avoid Production Losses during Varnish Elimination

Ocean Team saves customers for huge amounts of money by eliminating varnish formation in turbine systems offshore without any system shutdown.

A customer in Qatar was experiencing challenges with a tripping Solar Gas Turbine located on an offshore production platform. After Ocean Teams inspection of the turbine and analysis of an extracted oil sample, it was clear, that the turbine was infected with varnish.

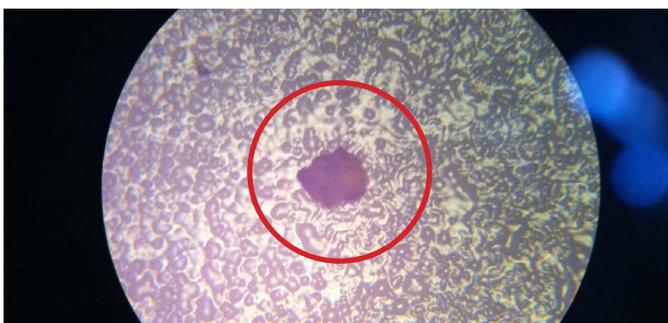
Picture 1 – ISO 4407 microscopic analysis showing the chemical reaction caused by worn out additives.

In due time it is unavoidable that the additives will get worn out and then fall out as microscopic particles with a size below 1 micron. Together with an increasing TAN value, due to worn out calcium additives, these particles will create a chemical reaction in the oil. This reaction can be seen in the pictures below.

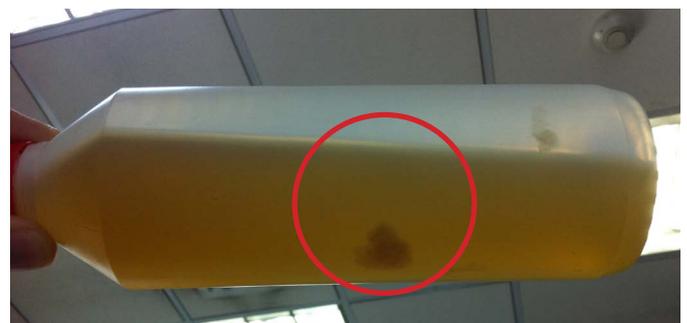
Picture 2 – Clear worn out additives from an oil sample.
