CASE: Complete Turbine Decontamination within 10 Hours

A customer in Qatar was experiencing challenges with a tripping Solar Gas Turbine located at an off-shore production platform. After Ocean Team's inspection of the turbine and analysis of an extracted oil sample, it was clear, that the turbine was heavily contaminated with particles and remains of oxidation.

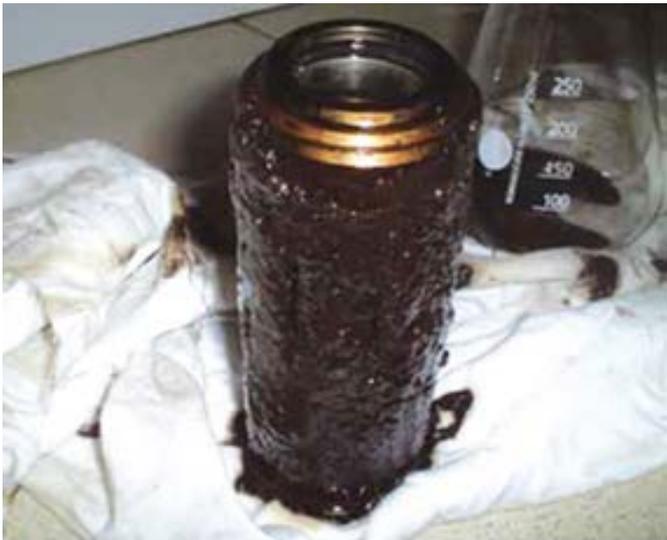
Picture 1 – Plugged filter with remains of oxidation from a large-frame industrial gas turbine.

But Ocean Team had a better solution: To eliminate the heavy contamination by means of an offline decontamination method, which saved the customer for the time-consuming draining and mechanical cleaning of the oil tank.

Our method is based on a special high flow filtration technique. We filtered the turbine oil with a capacity at up to 900 litres/minute. This caused the oil to stress and by this loose up in the contamination and carry it out to be captured by the offline decontamination unit.

Ocean Team's solution showed to be a much faster way to clean the turbine oil compared to the known mechanical alternative. The infected turbine oil had a cleanliness level equalling ISO 4406 standard code 23/21/18. Within only 10 hours, we managed to bring down the cleanliness level of the 12,000 litres of turbine oil as much as 8 classes to an optimum level at 15/13/10.
